MWI FIELD TRIP REPORT DURING INTIAL TESTING OF PUMPING EQUIPMENT DTD 24 APRIL 2006

MWI FIELD TRIP REPORT

Dennis Strecker

April 24, 2006

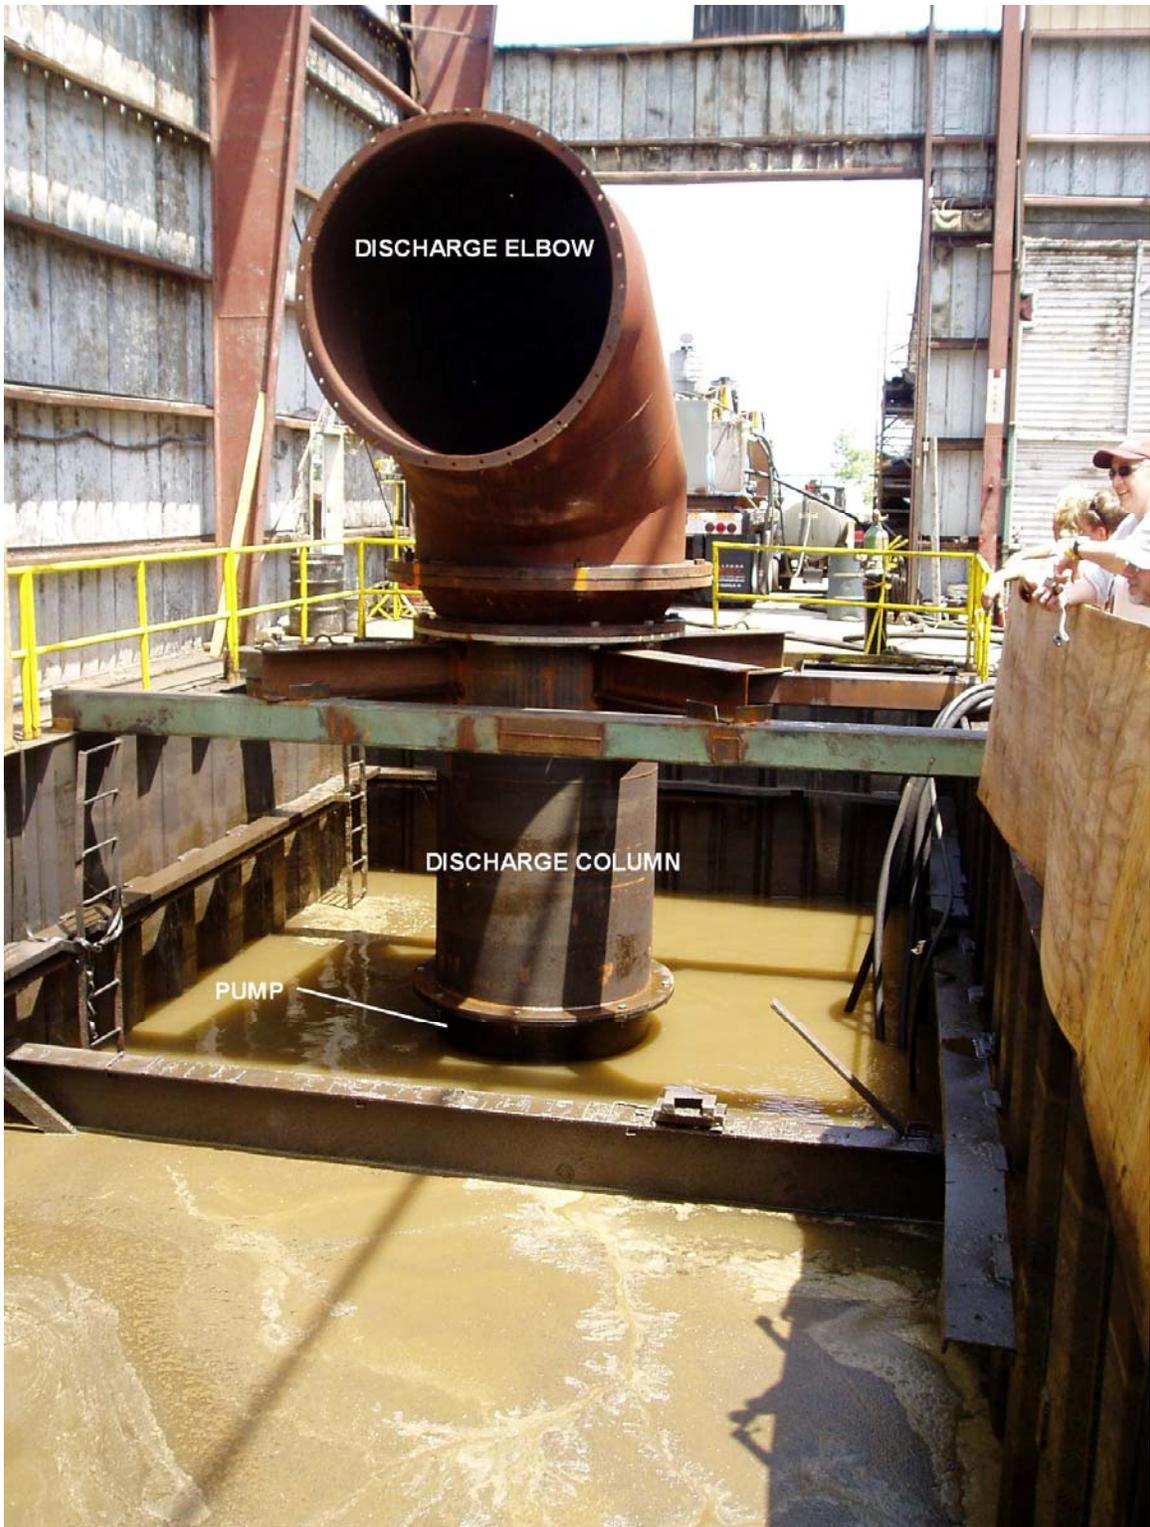
Figure 2

degree elbow. The pump discharged from the elbow into the tank. Near the top of the discharge column, shown in Figure 2, was a hole for passing the pitot pipe into the discharge column flow. The pitot pipe was a long pipe, approximately 1" in diameter, capped on one end and with a hole in its side for measuring stagnation pressures. Attached to the other end of the pitot tube was a clear plastic tube which connected to a manometer constructed from a vertical aluminum "U" channel. The other end of the manometer was connected to measure undisturbed or static pressure. The difference between the stagnation pressure and undisturbed pressure was the dynamic pressure. The dynamic pressure was used to calculate the velocity at the location of the reading using the formula $h=V^2/2g$ where h was the dynamic pressure in feet, V is the fluid velocity in feet per second and g was the acceleration of gravity (32.2 feet/ second²). Ten readings were taken across the pipe and later averaged to get the average velocity. From the cross sectional area of the discharge column, and the average velocity and the flow were calculated. The static head was determined later by measuring the stagnation pressure.

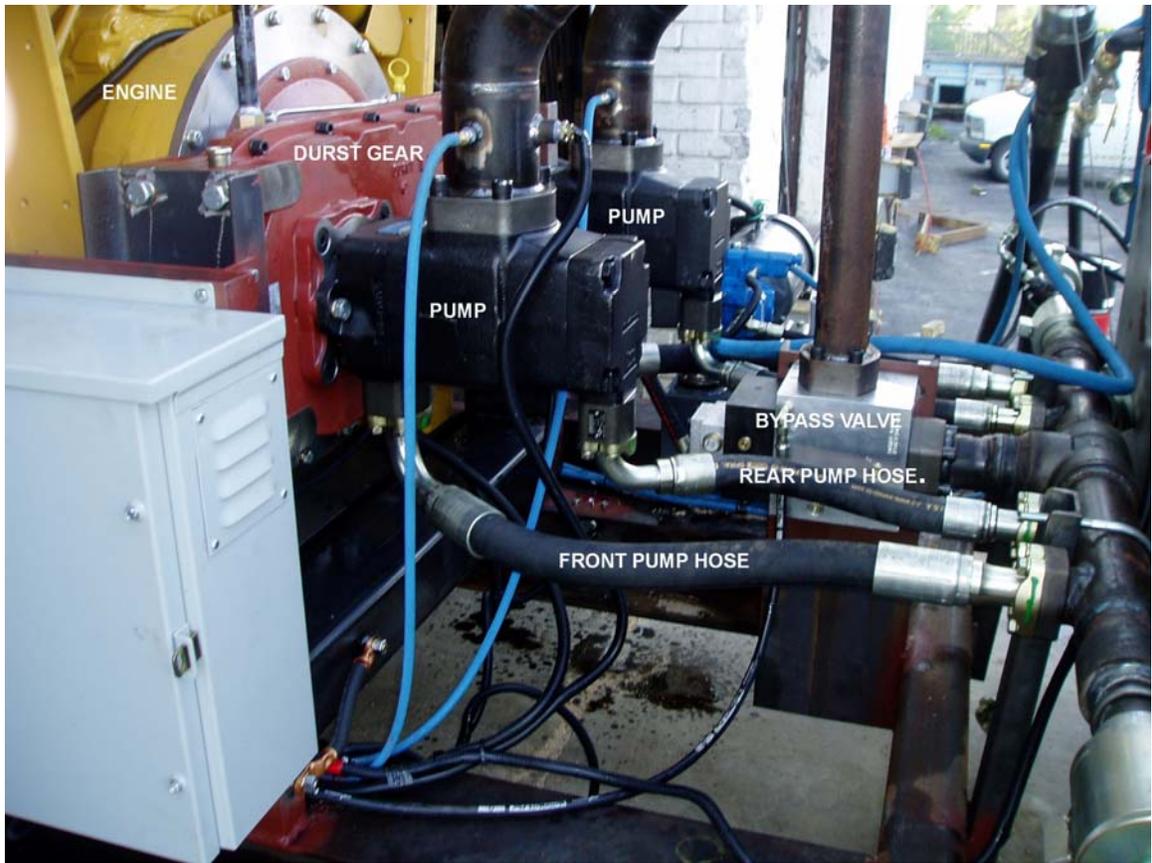
Figure 4

The test site had many safety hazards. Some as a result of a recent fire in which one person died and the test building was left without a roof. The accident occurred from weld splatter or sparks while supports were installed for two ten ton gantry hoists. The hoists would have made it easier to install the pumps into the tank. Since they didn't have a gantry crane, the contractor had to use a mobile crane. The original job of installing gantry cranes was still in progress when I was there and there was always an awareness of people working overhead from man lifts. At one point, a sling fell into the test tank during a test and had to be retrieved by diving. Another hazard was the location of the HPU. In order to save time, the HPUs were left on a flat bed truck during the test. Access to the HPU was by portable stairs, but to get around while inspecting the various components required walking on oily surfaces with narrow ledges on both sides of the unit and hot surfaces everywhere. What I felt was a potential health hazard was the mist of oil laden test tank water given off during the test. Fortunately, for the 5 hour endurance tests, temperature readings were made every 30 minutes, allowing the inspectors to sit outside between readings.

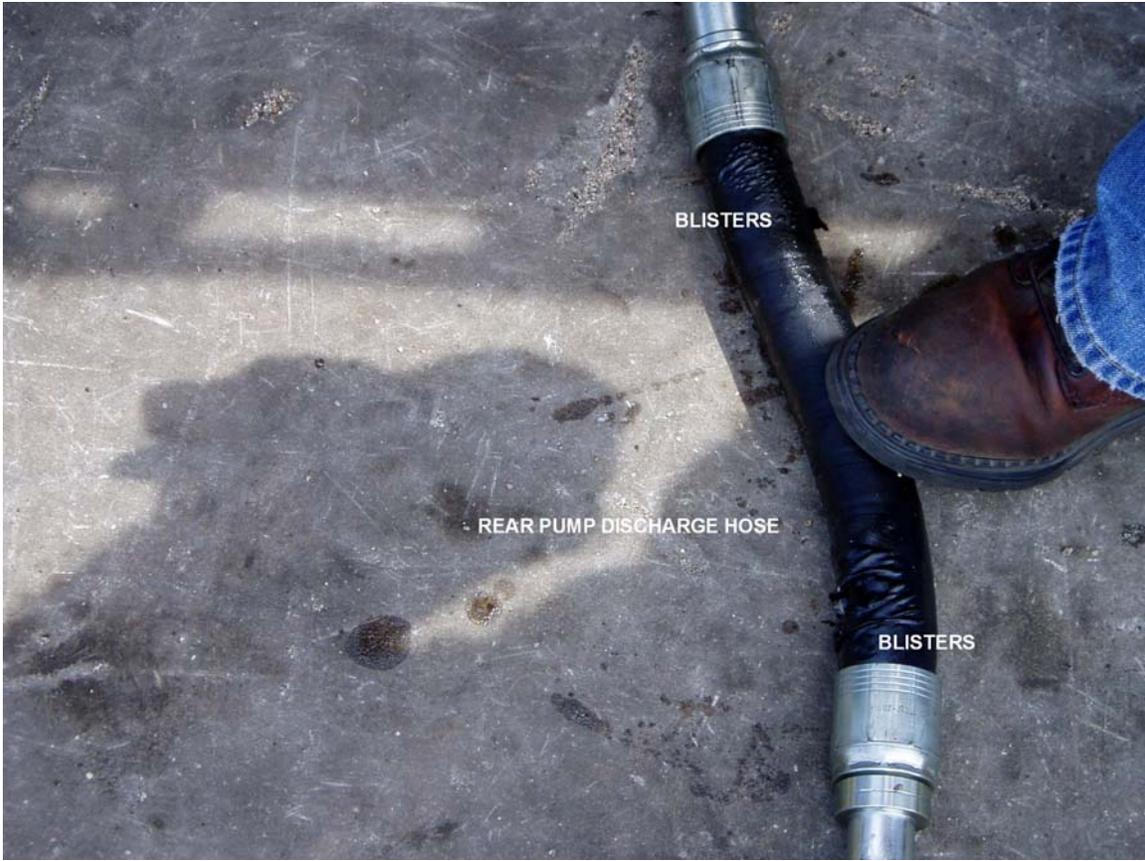
Figure 5

A potential fire hazard existed with the HPUs. On two occasions a hose on the rear pump of one of the double vane pump sprang a leak. The leak developed from blistering on the hose's jacket near the fittings, followed by a high pressure fine mist spray of hot oil. The pump was manually shutdown before the condition developed further. The hoses were located between the rear of the engine and the hydraulic reservoir and fuel tank. They were near the engine exhaust turbochargers. The rupture I observed occurred on the bottom side of the hose. There was a potential for a rupture which would spray oil on the engine exhaust or turbochargers. Operating pressures on the pump discharge hoses were 3000 psi.

1. The Corps should verify pump capacity with field testing. Because of the large clearance between impeller and impeller bowl of approximately $\frac{1}{4}$ " and less than ideal test conditions at the factory, a field test on one pump should be conducted. Typically, impeller to impeller bowl clearance is on the order of 0.060" for a 60" pump.
2. A spray shield between the hydraulic system hoses and engine exhaust should be installed. In the event of a ruptured hose, a spray shield would prevent hydraulic fluid from spraying on the engine's hot exhaust.
